DEPARTMENT OF TRANSPORTATION

Contract #: 04-0120F4Cty: SF/ALA Rte: 80 PM: 13.2/13.9File #: 1.28**WELDING INSPECTION REPORT****Resident Engineer:**Siegenthaler, Peter**Address:** 333 Burma Road**City:** Oakland, CA 94607**Report No:** WIR-020900**Date Inspected:** 19-Feb-2011**Project Name:** SAS Superstructure**OSM Arrival Time:** 800**Prime Contractor:** American Bridge/Fluor Enterprises, a JV**OSM Departure Time:** 1530**Contractor:** American Bridge/Fluor Enterprises, a JV**Location:** Job Site**CWI Name:** Mike Johnson**CWI Present:** Yes No**Inspected CWI report:** Yes No N/A**Rod Oven in Use:** Yes No N/A**Electrode to specification:** Yes No N/A**Weld Procedures Followed:** Yes No N/A**Qualified Welders:** Yes No N/A**Verified Joint Fit-up:** Yes No N/A**Approved Drawings:** Yes No N/A**Approved WPS:** Yes No N/A**Delayed / Cancelled:** Yes No N/A**Bridge No:** 34-0006**Component:** SAS Tower**Summary of Items Observed:**

WELDING INSPECTION REPORT

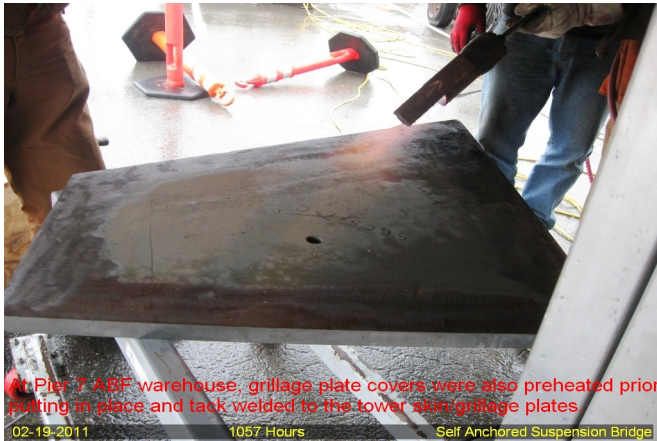
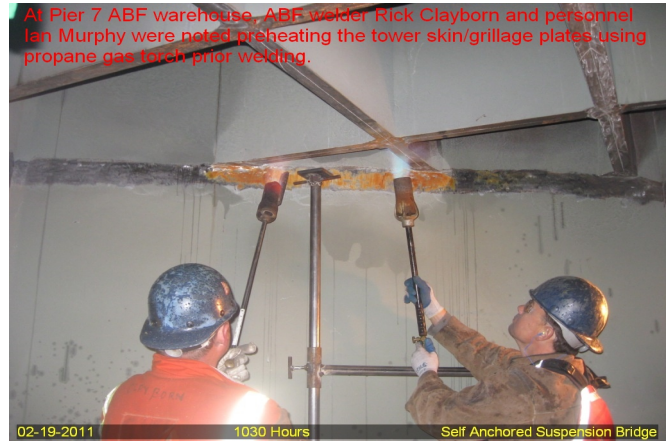
At Pier 7 ABF warehouse, this QA performed random observation on the fit up and tack welding of the cover plate made on SAS Tower Grillage South Shaft. The ABF welder Rick Clayborn was observed performing tack welding on the one inch thick cover plate with various dimensions to the 90mm tower skin plates and 70mm grillage plates. The welder was noted tack welding in 4F (overhead) position utilizing 1/8" diameter E9018H4R electrode implementing Caltrans approved Welding Procedure Specification (WPS) ABF-WPS-D15-F026-4. The paint coating on the cover plates and the skin/grillage plates were ground removed and the plates were preheated to more than 225 degrees Fahrenheit prior welding. During tack welding, ABF QC Mike Johnson was noted monitoring the welding parameters of the welder. QA performed parameter check during welding with 130 amperes noted reading using the digital clamp meter which deemed in compliance to the approved WPS. At the end of the shift, the following south shaft grillage cover plates were tack welded;

1. S-GC5-21C – tack welded
2. S-GC5-7C – tack welded
3. S-GC5-6B – tack welded
4. S-GC5-1A – tack welded
5. S-GC5-1B – tack welded
6. S-GC5-2A – tack welded

7. S-GC5-3E – put in place
